BRITANNIA FIRE

PRODUCT CASE STUDY

NETHERLANDS

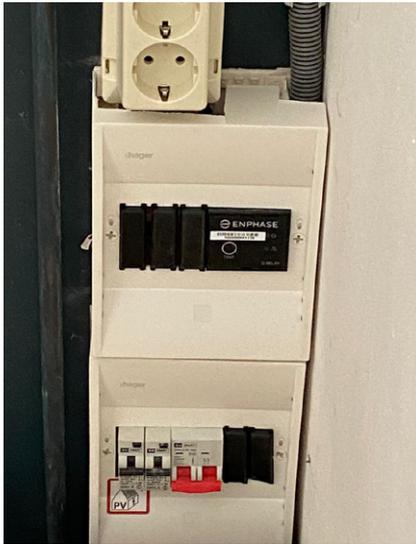
1 On Arrival - Burning Smell

Firefighters were called by the property owner as he believed he had an electrical fault and there was a smell of burning.

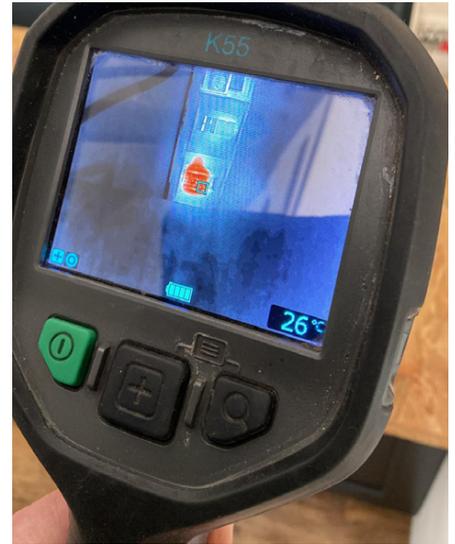
3 Thermal Image Camera

On arrival they isolated the power, but using the thermal image camera they could see that the electrical problem remained (DC electricity from the panels to the inverter) and excess heat remained.

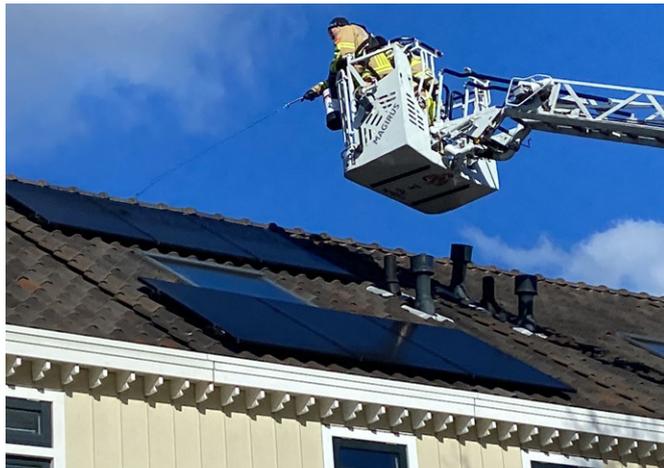
4 PVSTOP application

They called to the fire station and had PVSTOP delivered, which was then applied to the solar panels on the roof via the aerial truck platform.

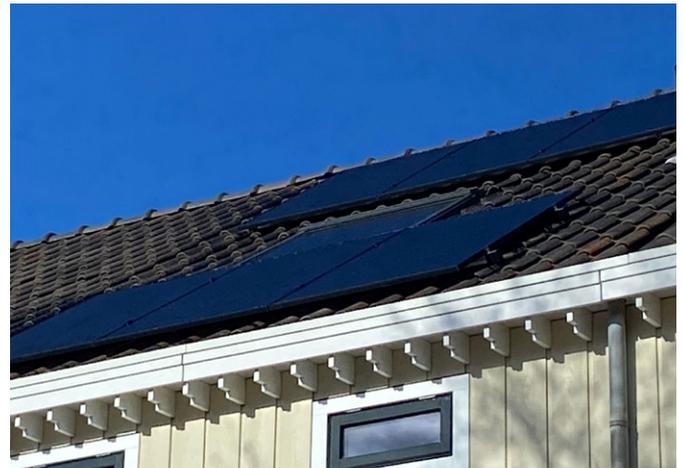
5 PV System safely de-energised

Once the panels were covered with PVSTOP the solar system was de-energised, and the firefighters could leave the property knowing it was safe for the owner to wait for the electrician to attend.
